SuDSPlanter case study

Project: Wiltshire Residential Property

Location: Bradford-on-Avon

Date: Aug 2017

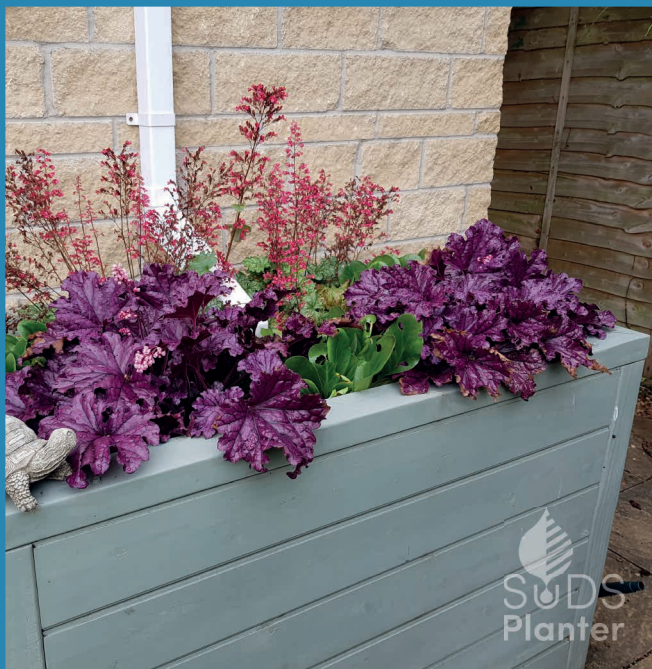
P.1. The SuDSPlanter in full flourish post summer's 2018 drought. A mix of soil media, water retention and suitable plant selections allow the plants to flourish in all climates.

The SuDSPlanter also survived the summer 'drought' period without requiring further irrigation during almost two months of no rain and unusually hot weather.

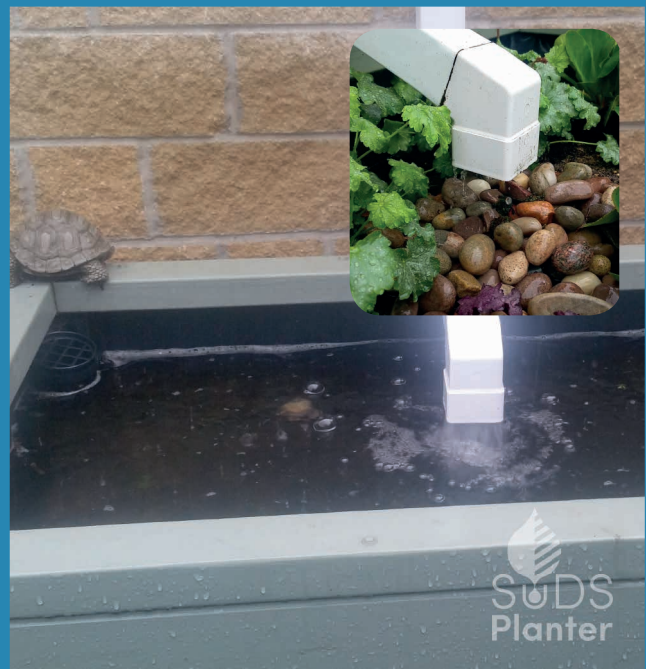
P.2. One of the many rainfall events monitored pre and post planting, recording the SuDSPlanters performance over the past 12 months.

Various outlet configurations have been monitored for over a year resulting in a range of useful observations and data on the hydraulic performance of the SuDSPlanter. A weather station providing real time rainfall and environmental data was also installed with the planter to provide rainfall input data to tie in with the collection of outlet and performance data.

It was demonstrated that during the year to the end of August 2018 it was possible to prevent the rainwater from all but three of the rainfall events from entering the surface water drainage system. These three events were also well attenuated, slowing and reducing the flow out of the SuDSPlanter during the storm events.
